**MICROSTRUCTURAL ALTERATIONS IN ALUMINA
CERAMICS ASSOCIATED WITH BALLISTIC IMPACT EVENTS**

C. H. Kim and H. Palmour III

Technical Report 70-8

December 1970

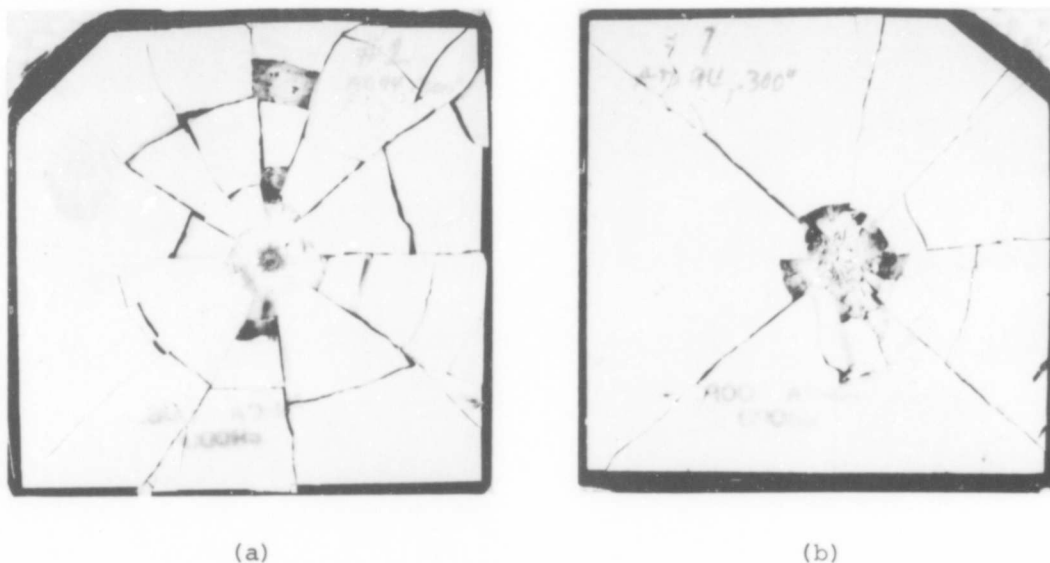
Figure 2. Macroscopic damage in alumina armor tiles caused by ballistic impact with different projectiles at 2240 feet per second: (a) 0.30 caliber ball (lead alloy); (b) 0.30 caliber APM-2 armor piercing (reassembled front faces of 6 inch \times 6 inch \times 0.30 inch alumina ceramic tile 1 (a) and tile 7 (b); corner had been removed from each tile prior to impact to serve as unshocked control)

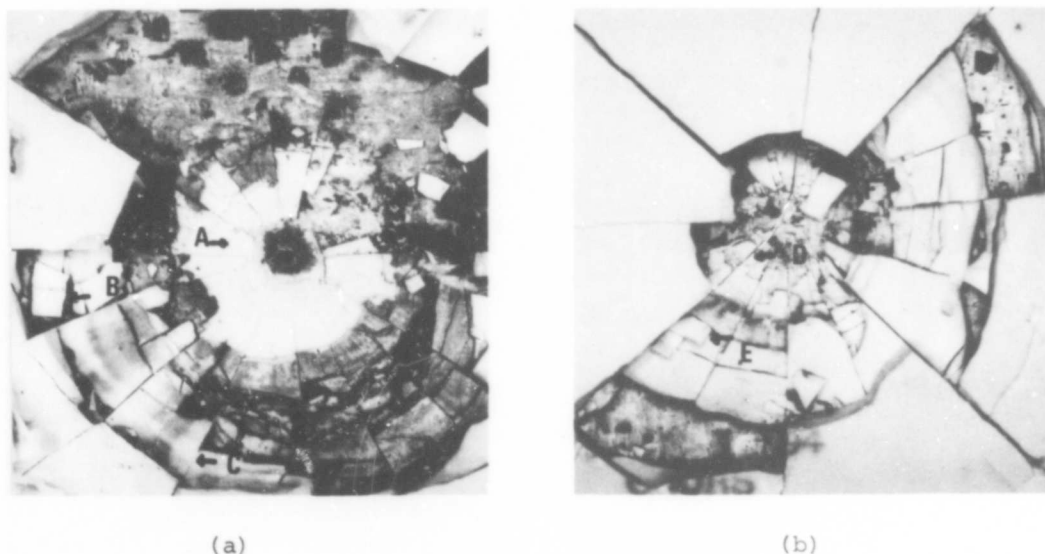
Figure 3. Interior views of 6 inch \times 6 inch \times 0.30 inch alumina ceramic tile 1 (a) and tile 7 (b) after removal of frontal spall fragments (arrows and letters indicate chips sampled for transmission electron microscopy studies)

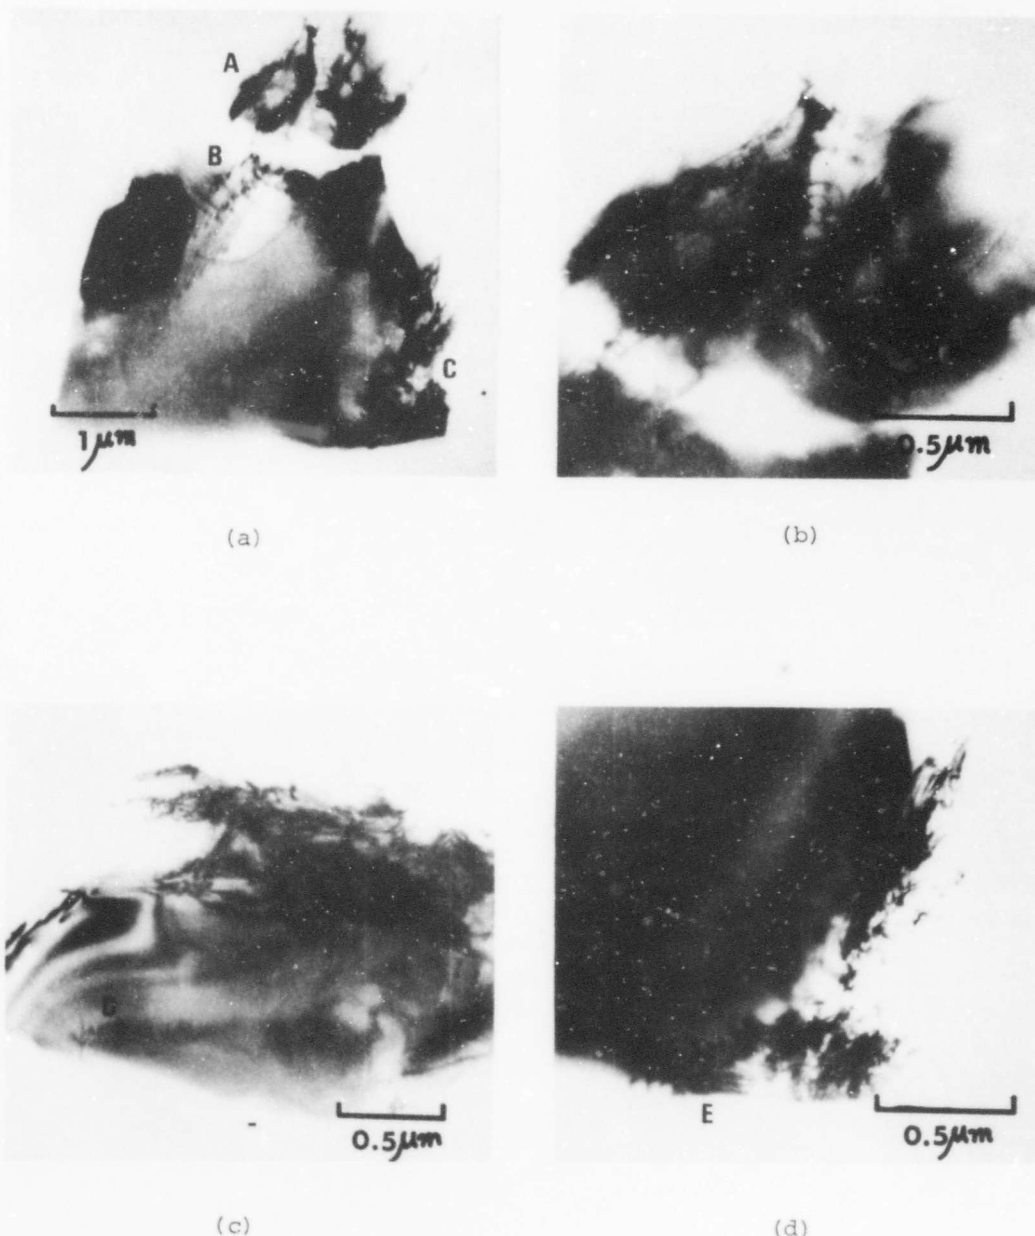
Figure 5. Structural defects in extracted fracture fragments from smooth radial surface in ballistically damaged polycrystalline alumina tile (letters locate dislocations and other features described in text): (a) diffraction contrast micrograph associated with defects in the regions marked A, B, and C; (b) higher magnification micrograph of the region marked A in Figure 5a; (c) dislocation arrays in the region marked D; (d) dislocation arrays and interactions in the region marked E

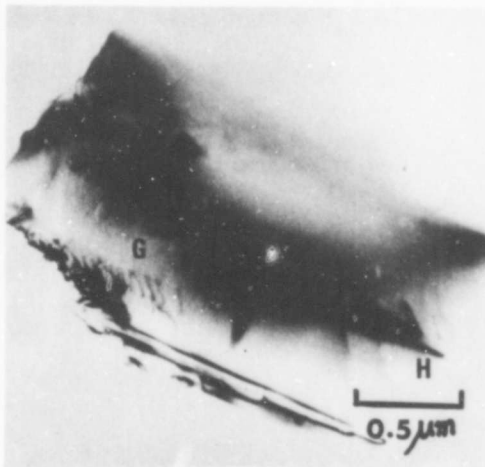
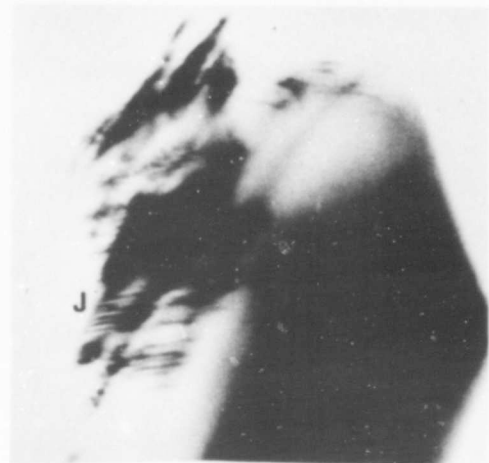
The later portions of the primary radial cracks are composed of very rough surfaces with complex textures. Figure 6 shows diffraction contrast micrographs of an extracted transparent fragment on a replica from such a rough surface.

Figure 6. Structural defects in extracted fracture fragments from a rough radial crack surface in ballistically damaged polycrystalline alumina tile (letters locate dislocations and other features): (a) high density dislocation arrays and other features in the region marked F; (b) dislocation arrays and interactions in the regions marked G and H; (c) heavy concentration of dislocations in the region marked J

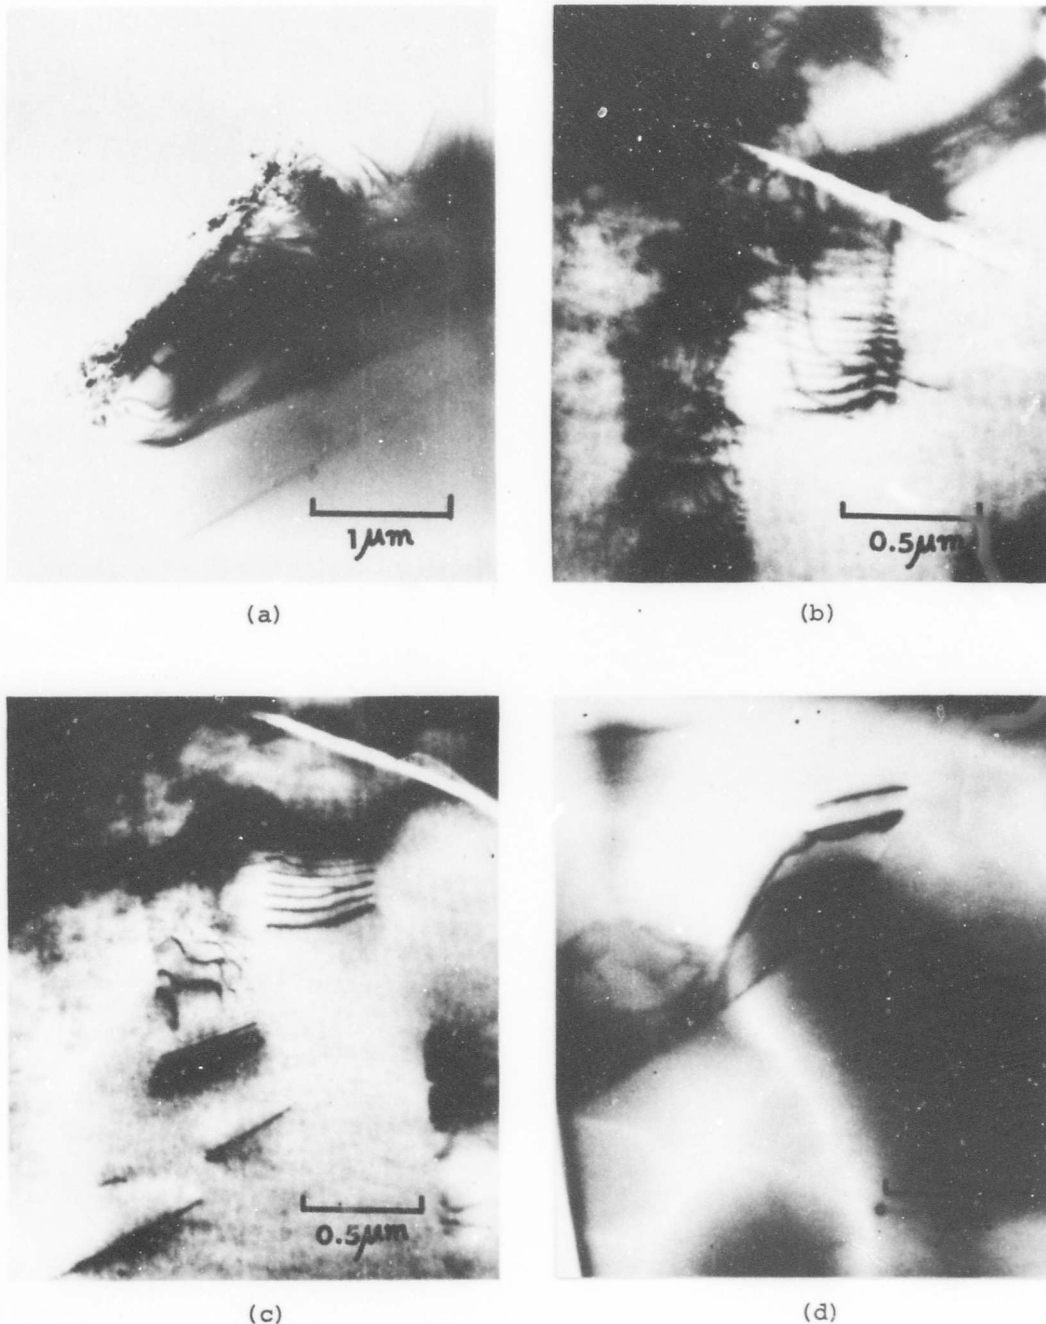
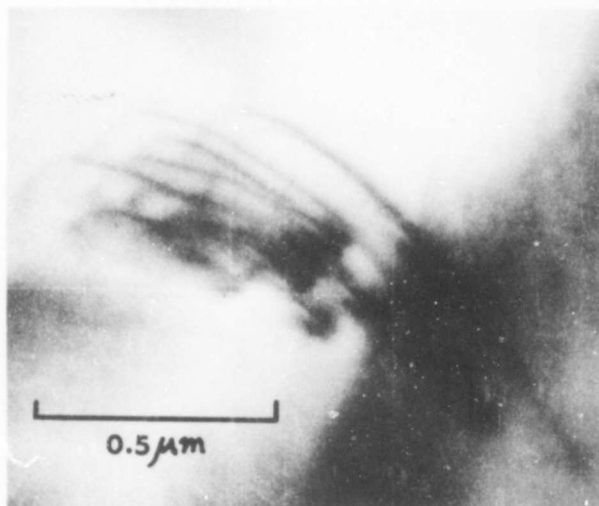
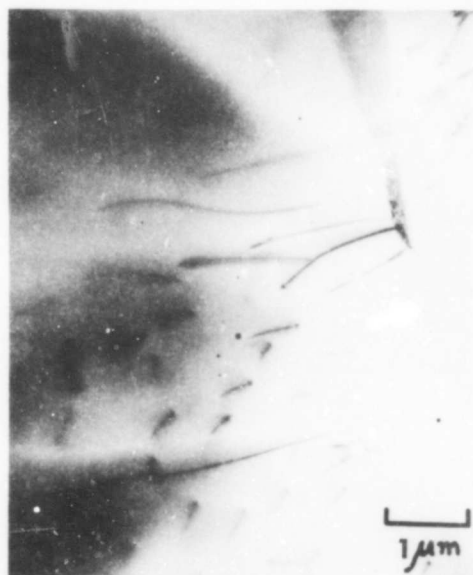
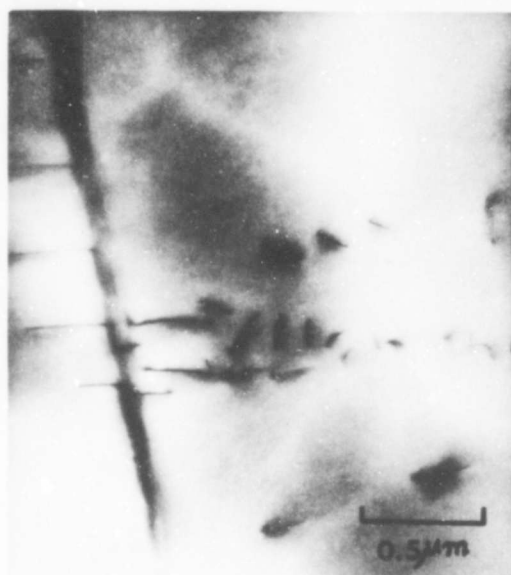
The interaction of a group of dislocations adjacent to a transverse crack are shown in Figures 11b and 11c which have slightly different orientations with respect to each other. Extension of slip bands was halted in the interior of the grain possibly because of unseen barriers which lay above or below this very thin foil.

Figure 11. Dislocation structures associated with ballistic impact in polycrystalline alumina (tile 1, chip C, Figure 3a): (a) heavily interacted dislocation structures at the edge of an isolated thinned grain; (b) the extension of slip bands adjacent to a crack; (c) the same area as (b), tilted to slightly different orientation; (d) dislocation loops formed during glide; (e) bowed-out dislocations; (f) individual dislocations; (g) dislocation is segmented by an obstacle

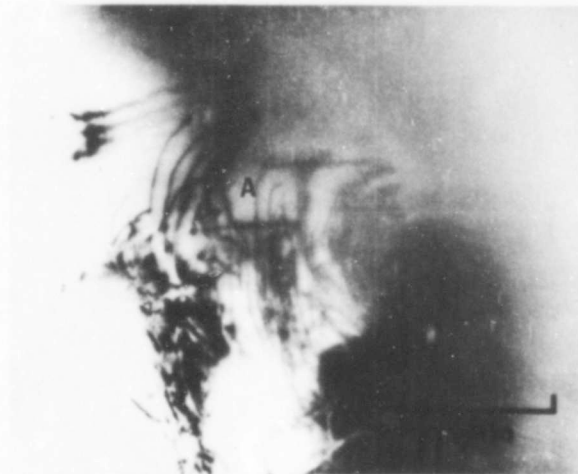
Several sets of dislocations are involved in Figure 15. It is likely that two, perhaps three, different slip systems have been involved in producing the dislocation tangles. Tilting experiments on this foil using the invisibility criterion $g \cdot b = 0$ showed one set of dislocations (marked A) to have the Burgers vector $\langle 11\bar{2}0 \rangle$ type. Others could not be positively identified.

Figure 15. Tangled mass of dislocations in ballistically damaged polycrystalline alumina (tile 7, chip E, Figure 3b)

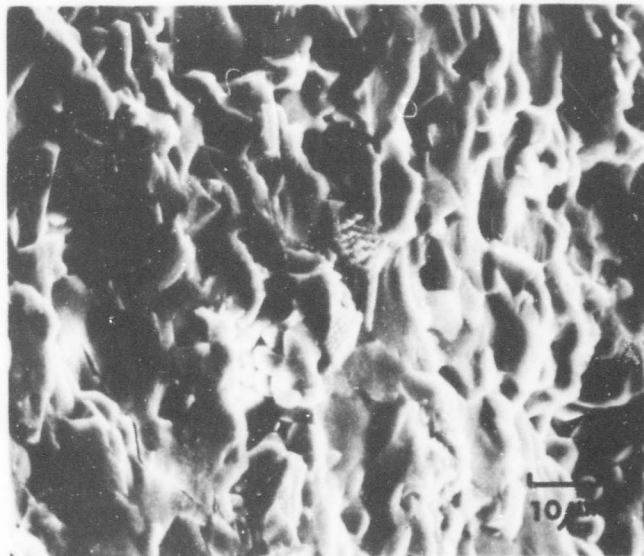
A low magnification micrograph of the fracture surface is shown in Figure 16. Several pores between grains, internal cracks, cleavage fracture facets, and river marks are visible in this micrograph.

Figure 16. Scanning electron micrograph taken from a fracture surface of ballistically damaged alumina (tile 1, central impact region, Figure 3a); intergranular and transgranular fracture facets with internal crack path are visible
